NATIONAL ADVISORY COMMITTEE FOR AERONAUTICS

WARTIME REPORT

PRELIMINARY REPORT ON FLIGHT TESTS OF AN
AIRPLANE HAVING EXHAUST-HEATED WINGS

By Lewis A. Rodert, William H. McAvoy, and
Lawrence A. Clousing

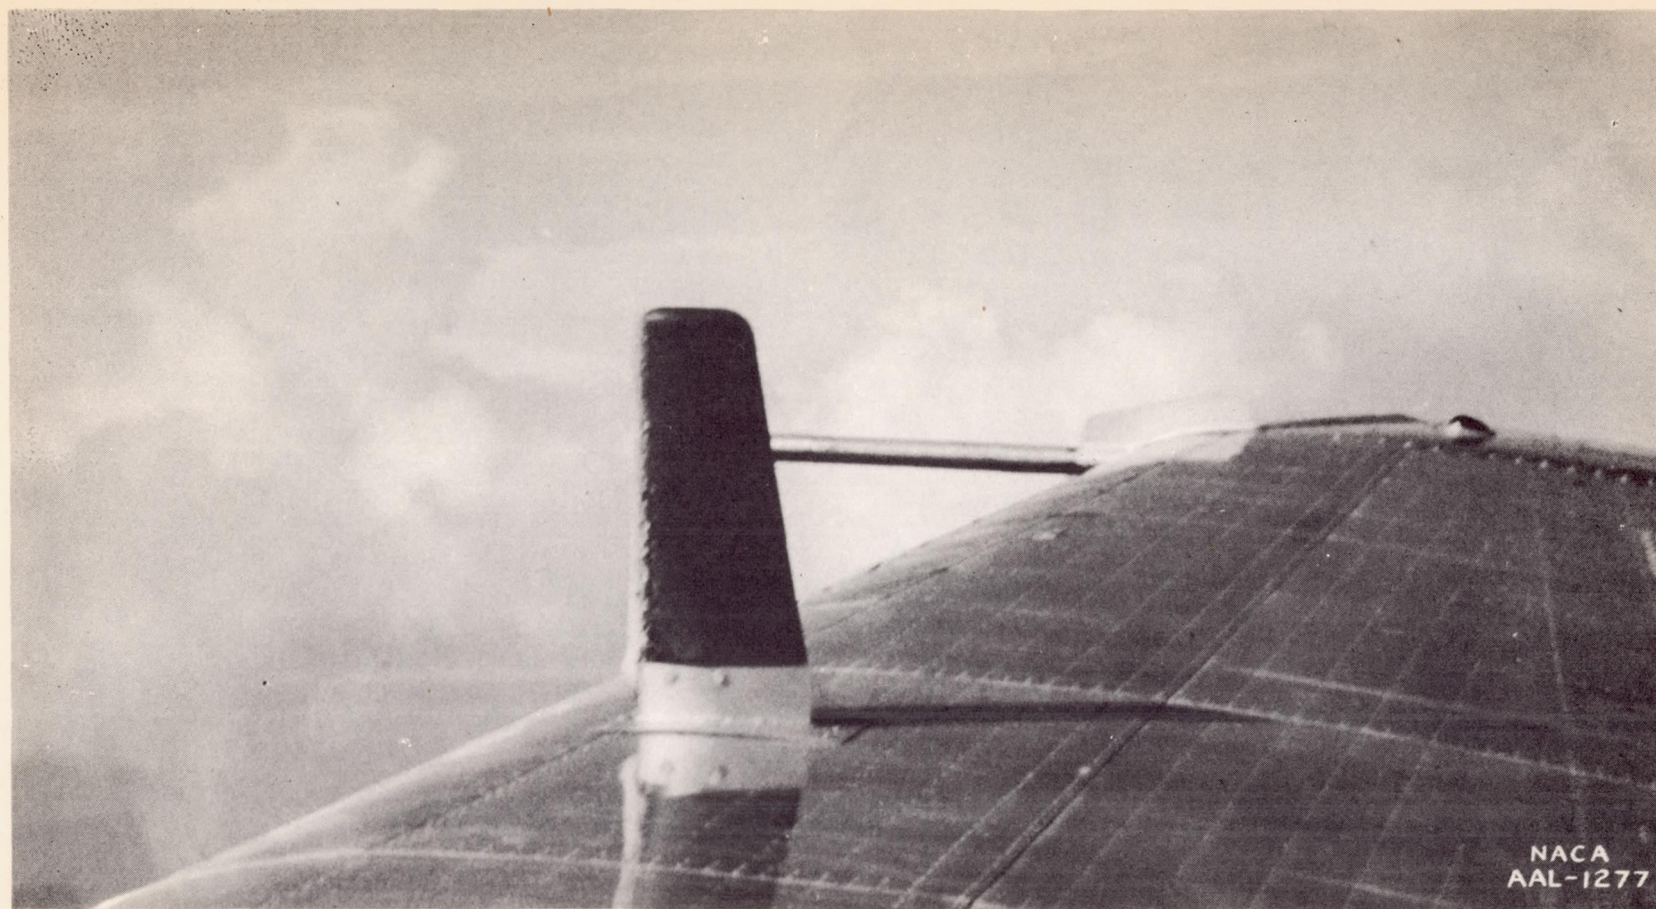
Figure 22. -

Ice prevention on the wing of the Lockheed 12-A airplane by the use of heat from the engine exhaust. The formation of ice on the strut in the foreground indicates the type of ice encountered.

Data: Airspeed, 140 m.p.h.; altitude, 8,000 to 8,500 feet; cumulus and cumulus stratus clouds; air temperature, 25° F.; air, very rough; types of ice, glaze and rime; rate of icing, undetermined. The flight was made in the vicinity of Medford, Oregon, over the Coast Range Mountains.

The heat which was supplied to the wing by the exhaust duct along the leading edge successfully prevented the formation of ice on all flights. Figures 20, 21, and 22 show photographs of the wing which were made during icing flights. Data which describe the conditions encountered during the flights are shown with the photographs. When icing conditions were encountered with air temperatures below 0° F, a tendency for ice to form around the air intake on the wing leading edge was observed. Under similar conditions, or when the wing heating system was operated on less than full heating capacity, thin sheets of ice about 1/16 inch thick formed on the wing surface in the vicinity of the trailing edge. The nature of the formation of ice along the unprotected wing leading edge between the fuselage and engine nacelle is shown in figure 23.

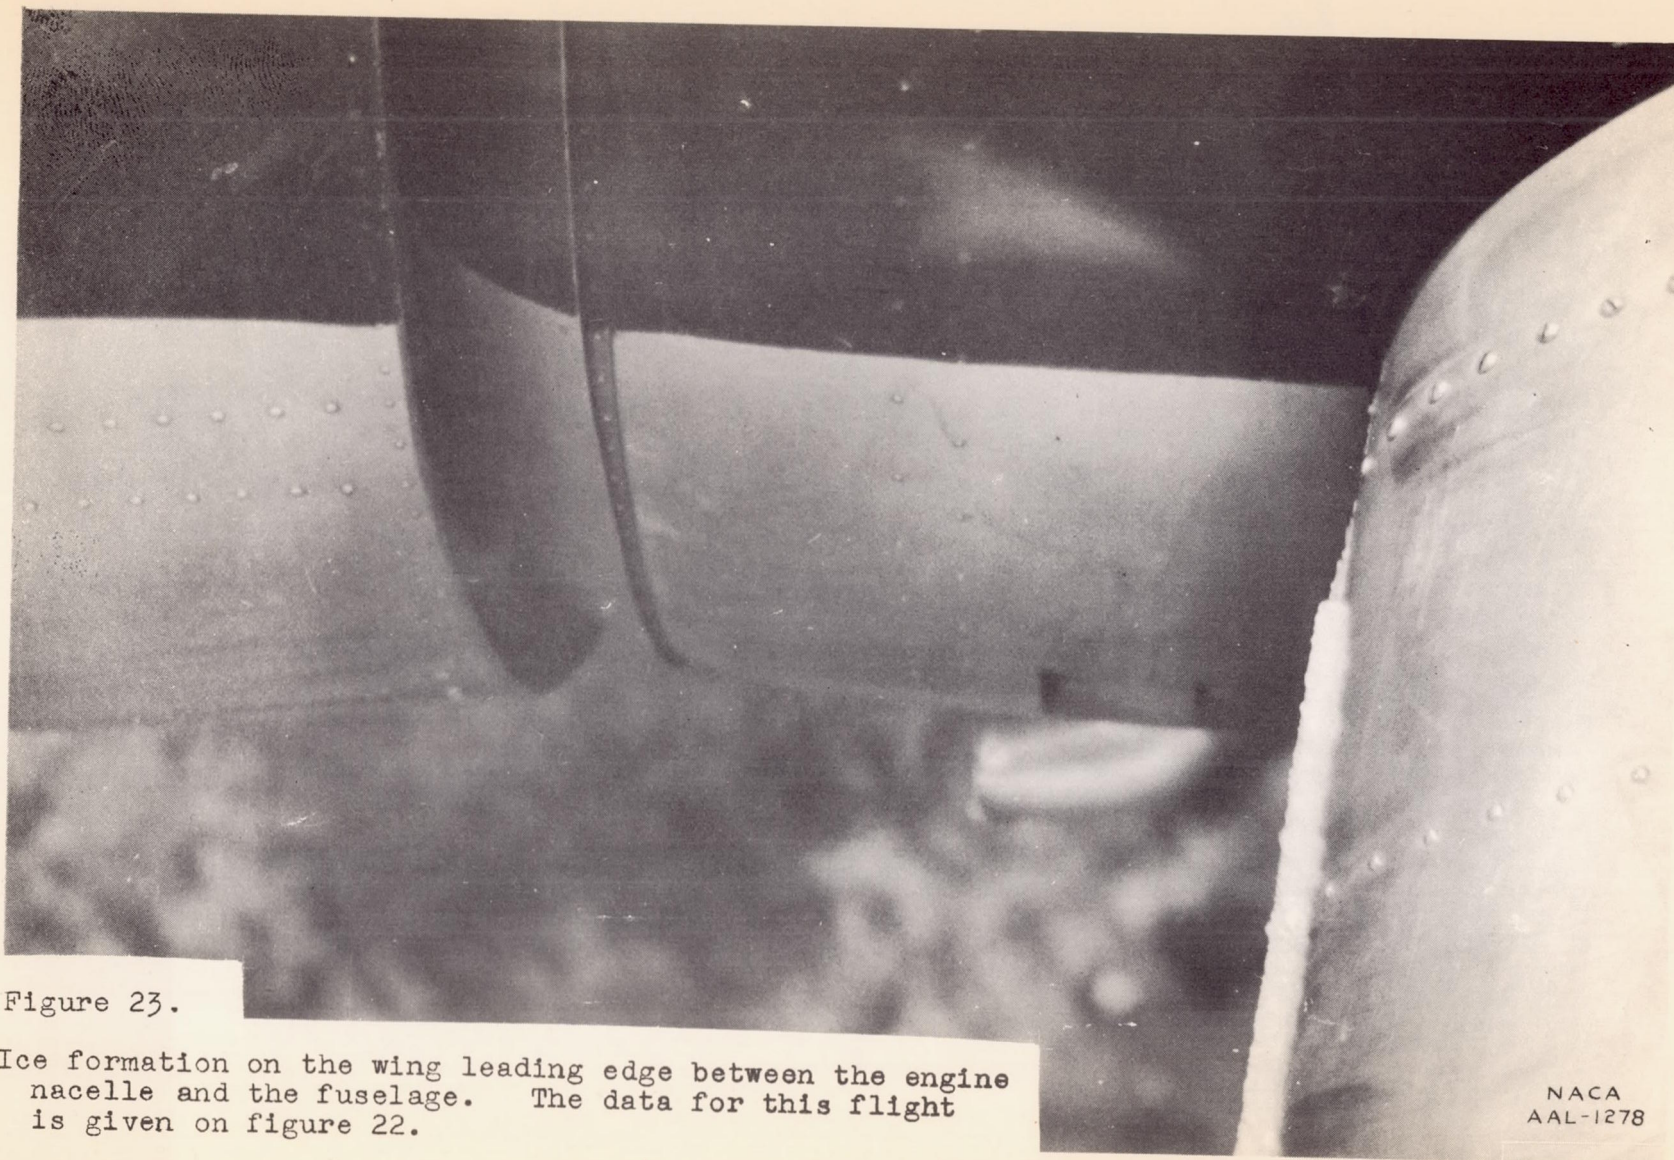
Figure 23.

Ice formation on the wing leading edge between the engine nacelle and the fuselage. The data for this flight is given on figure 22.

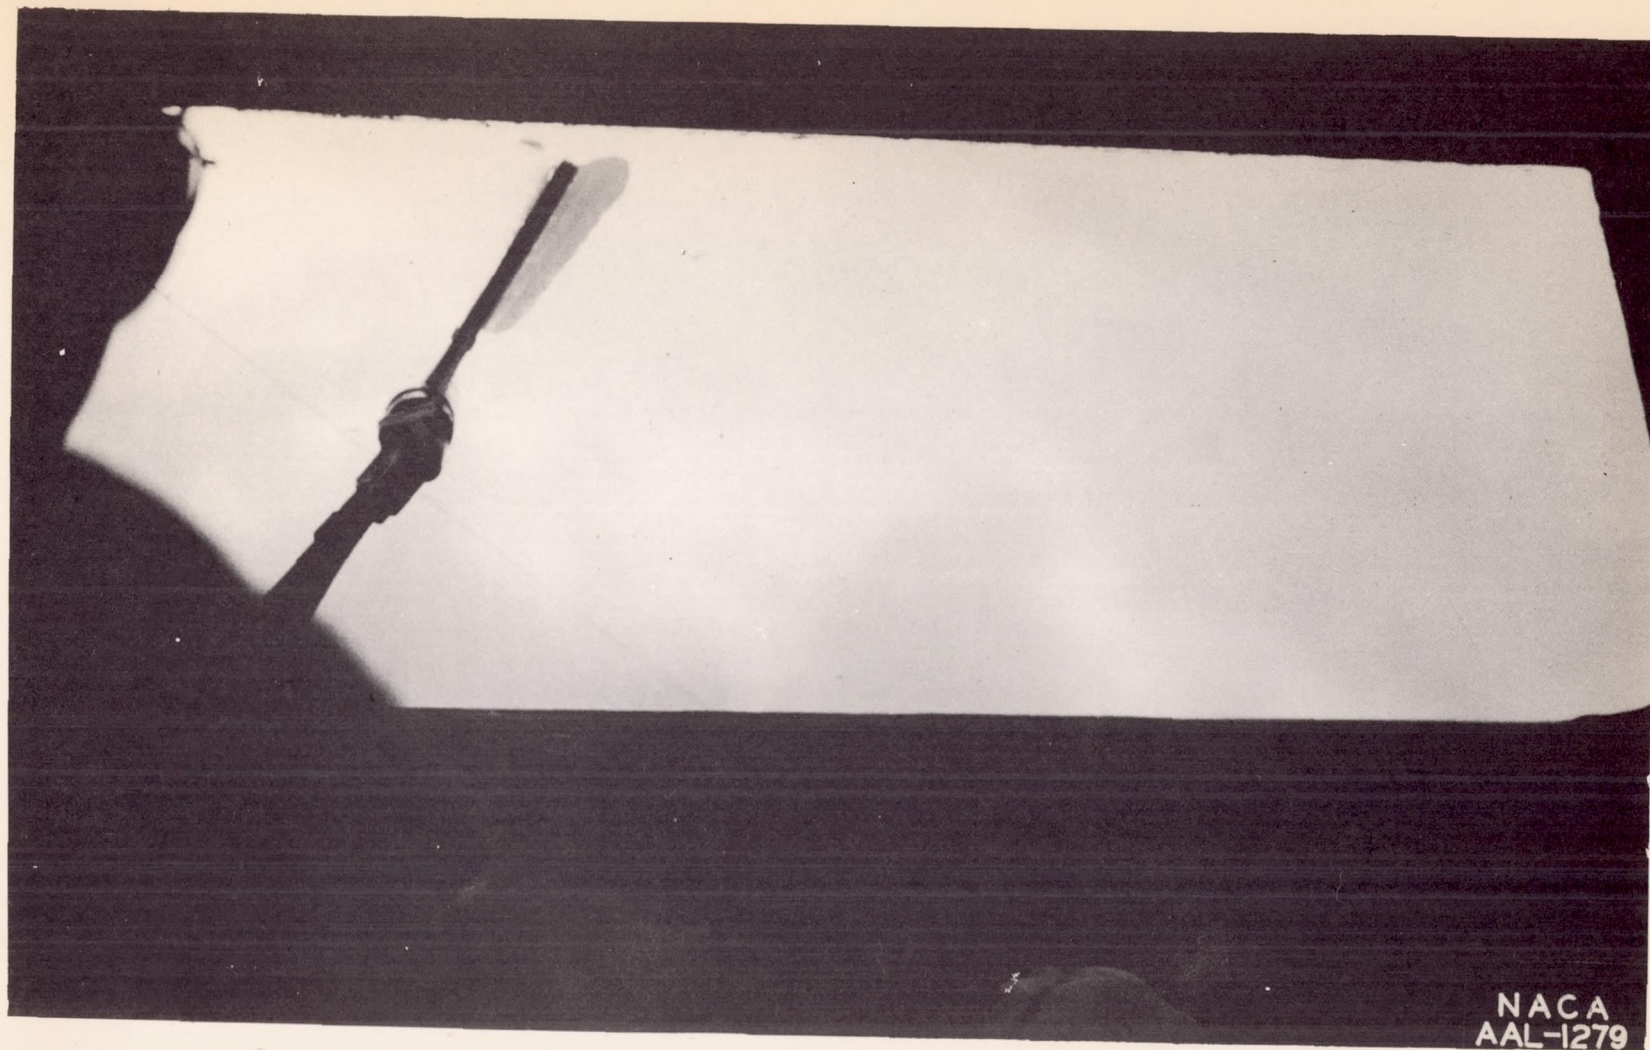
Figure 24. - A view through the pilot's windshield during an icing flight. The glass is free from ice on the exterior and frost on the interior. The data for the flight is given on figure 21. The low air temperatures produced frost on the co-pilot's windshield interior; ice forming on the exterior. Ice is seen on the windshield wiper blade protruding to windward about an inch.

The prevention of ice on the pilot's windshield is illustrated in figure 24, in which the windshield is free of ice. During several flights, ice was allowed to form before the heat was turned on and it was found that ice could be removed as well as prevented. The windshield wiper was unsatisfactory because of ice formations on the blade, as seen through the windshield in figure 24, and because of uneven alcohol distribution over the swept disk of the wiper. The air stream lifted the wiper blade off the glass over a part of the arc of rotation, and ice formed on the glass over this region. It appears that the windshield heating as employed in these tests is adequate for protection against ice and frost.
